## Job Report #261404

Jul 15, 2026

| TYPE | CUSTOMER NAME | ADDRESS | PROPERTY NAME | PROPERTY ADDRESS |
|---|---|---|---|---|
| Non-Emergency Service | Sample Hospitality Group | 100 Example Ave., Toronto, ON M5V 1A1 | Sample Commercial Kitchen | 100 Example Ave., Toronto, ON M5V 1A1 |

Brad sent video and called Jon early Sunday AM regarding a leak involving the recirc pump for the HWT.

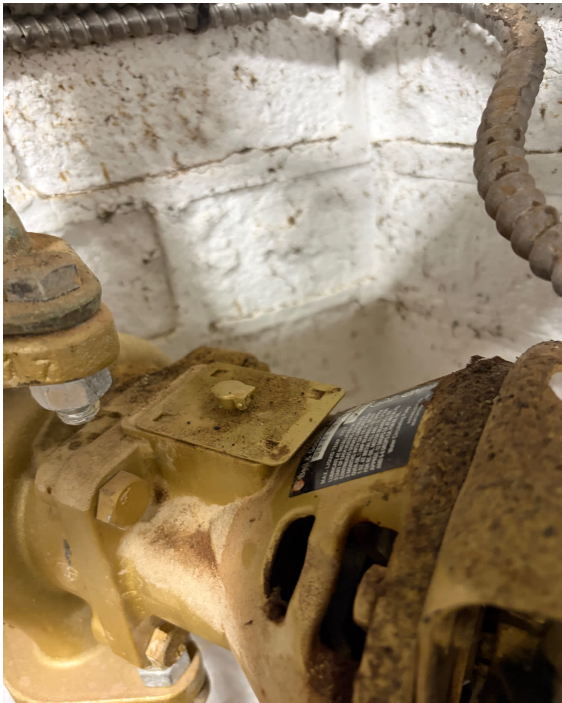
1

On June 29, 2026, I attended 100 Example Avenue, Unit 200, at the ground floor hot water tank area near the back door for tenant Sample Hospitality Group, having been called by Brad Almeida regarding a domestic hot water recirculation pump with a leaking bearing assembly. Upon arrival, I assessed the piping arrangement and electrical whip to determine whether a full pump replacement or bearing assembly replacement would be the most appropriate course of action. A quote will be submitted shortly to Brad for his review.

Dust indicates pump hasn't been oiled for quite some time

After receiving approval for the pump replacement the work carried out was as follows. I isolated the pump, drained down the immediate section of piping as required, and disconnected and removed the existing unit. I supplied and installed a new Grundfos UPS 26-99SFC circulator pump, using the required gaskets, bolts, and standard installation materials. Once installed, I reconnected the pump to the existing piping and electrical connection, filled and purged the system of air, and tested for proper operation. All connections were checked for leaks and the system was verified to be circulating as intended. Upon completion, the work area was left clean.

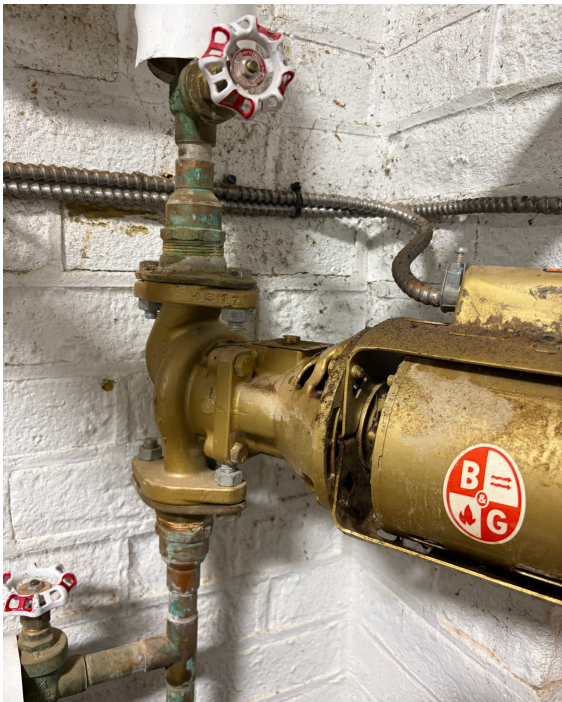
2

Old pump

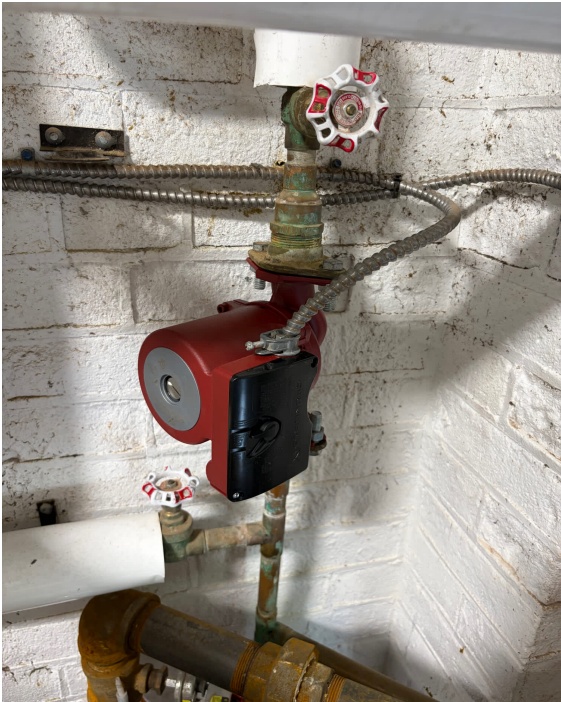
New Grundfos stainless steel recirc pump
